High-Energy Electromagnetic Wave Radiation Analysis Study of Laboratories Using Digital Medical Imaging Devices

Devices that acquire digital medical images using radiation (DR; Digital Radiography) are widely used in medical institutions to obtain information necessary for patient diagnosis, and the frequency of use is gradually increasing. By selecting 3 hospitals that perform more than 50 digital X-ray medical imaging tests per day, and by installing a glass dosimeter for environmental measurement on the outside of the examination room protection wall, entrance door, and patient viewing window, the leakage radiation dose was measured for one month from May 16, 2021 to June 21, 2021, then it was analyzed by converting into a 3-month cumulative dose. The cumulative dose equivalent of 1 cm in the glass dosimeter for 3 months outside the shielding wall at the entrance of the digital medical image acquisition radiation generating device examination room was 0.96 mSv, and the average value was 0.18 mSv. In addition, the cumulative 1 cm dose equivalent value of the glass dosimeter for 3 months outside the shielding wall on the control room side showed a maximum of 3.03 mSv and an avera

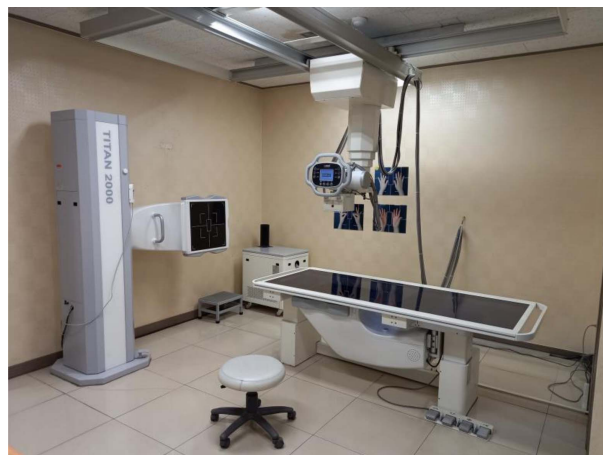
In this study, DK medical system Innovision (Ceiling Type - ELIN T5) was used to measure the radiation dose of the digital medical imaging radiation generator examination room protection wall (Fig. 1). Innovision device is a device that can quickly check a clear image with a low radiation dose and can be used easily and safely. This device is widely used as a device that supports conver-

Fig. 1. (Color online) Digital medical imaging device for measuring leakage dose in high-energy electromagnetic waves.

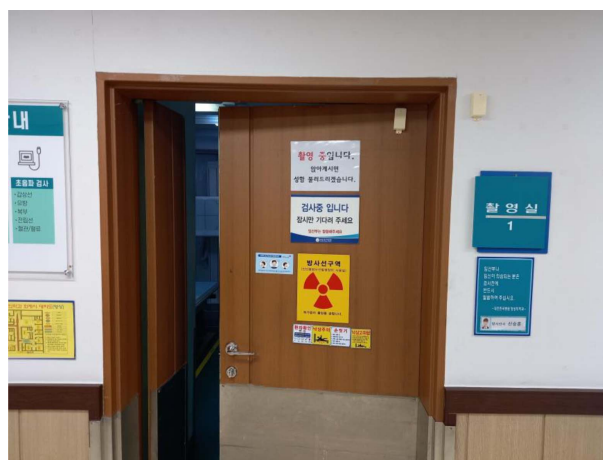
As the environmental leakage radiation measuring device, a glass dosimeter (Glassbadge: GB) RS of Chiyoda Technol Corporation of Japan suitable for medical X-ray measurement was used, and diagnostic radiation environmental radiation measurement location was measured by installing it at 150-170 cm from the floor considering the location of the radiation generator (Fig. 2).

Fig. 2. (Color online) Glass dosimeter installation location for high-energy electromagnetic wave measurement.

The installation location of the environmental glass dosimeter was attached at a height of 170-190 cm from the floor, where leakage and scattered radiation frequently occur, based on the legal standards for installing a protection wall. The environmental glass dosimeter dose analysis was compared and analyzed with the Japanese standard of 1 cm dose equivalent by multiplying the measured one-month cumulative dose by 3 times.

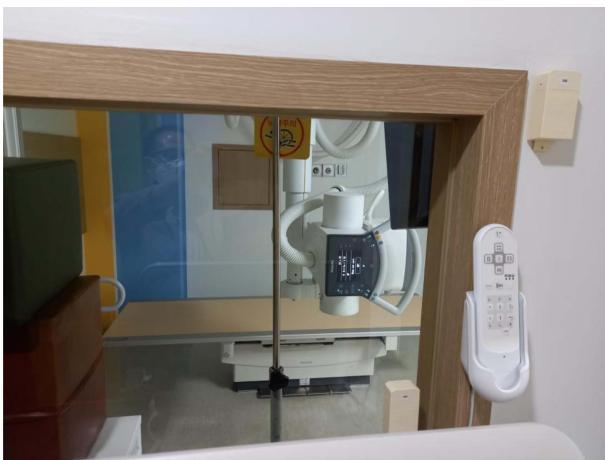
The glass dosimeter was installed at 150-190 cm from the floor considering the safety of the patient entrance and exit door, the entrance door of the digital medical image acquisition radiation generator control room, the shielding wall, and the patient viewing window based on the medical image X-ray examination room (Fig. 3).

To measure and evaluate the shielding efficiency of the patient viewing window, multiple glass dosimeters were installed inside and outside the laboratory to measure environmental radiation dose and verify statistical significance. The dosimeter recovered after measurement was delivered by air to Chiyoda Technol, Japan, without the procedure of passing the X-ray screening station, and the results were analyzed. By multiplying the measurement result by a factor of 3, a comparative analysis was performed with the Japanese medical radiation safety management standard.

Fig. 3. (Color online) Glass dosimeter installation location for lead glass leakage dose measurement.

The dose equivalent of 1 cm of accumulated dose of glass dosimeter for 3 months outside the digital medical image acquisition radiation generator examination room patient viewing window was measured to be less than or equal to the natural radiation dose in 10 examination rooms where the tests were conducted. These results show that the shielding performance of the digital medical image acquisition radiation generator examination room patient viewing windows of the measured medical institutions meet the medical radiation safety management standards of Korea and Japan.
